ISTA 6 - Amazon.com – SIOC - G Test Report_External

Vendor/Seller Name: HISENSE ELECTRIC CO.,LTD.**ASIN:** Click here to enter text.**Item:** 65A6501EUR, 65R8F, 65R8F5**Certification Passed:**

Test Requestor	HISENSE ELECTRIC CO.,LTD.
Project Name	ISTA 6-Amazon.com-SIOC:2018-Type G
Submission Date	7/5/2019
Due Date	7/8/2019

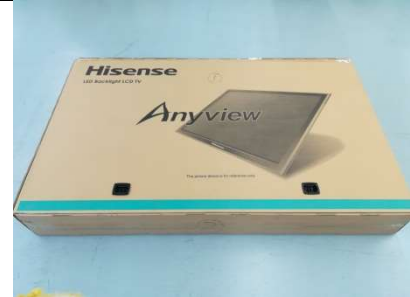
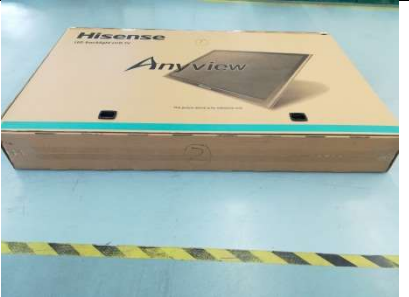
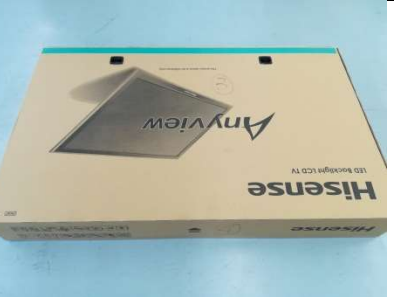
Side 1	Side 2	Side 3

Product Condition	Package was not opened before testing to review product.
Package Condition	Package was not opened before testing and the carton box was in good condition.
Package Condition before testing	<input checked="" type="checkbox"/> ORIGINAL as arrived in the lab for testing <input type="checkbox"/> NEW re-packaged with new materials before testing
Corrugated Info (Box Cert if available)	No Box Cert
Dunnage Info	N/A
Additional Notes	N/A

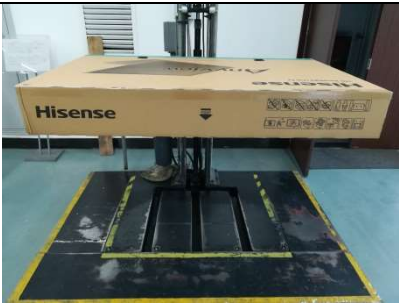
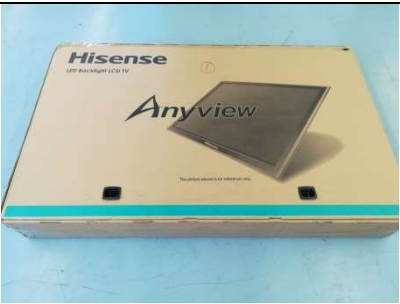
Block 2 Test Set Up	Block 2 Post Test Item Picture	Extra #

Test	Value	P/F	P/F	P/F	P/F	P/F	OBSERVATIONS
BLOCK 1:Temp and Humidity							26℃&69%R.H. for 12+ hours
BLOCK 2: Drop 1-7	18 INCHES	P	P	NA	NA	NA	
BLOCK 2: Drop 8	36 INCHES	P	P	NA	NA	NA	Face 3
BLOCK 2: Drop 9	18 INCHES	P	P	NA	NA	NA	
BLOCK 9: Clamping Simulation	800Lbs.	P	P	NA	NA	NA	
BLOCK 10: Compression	605.3Lbs.	P	P	NA	NA	NA	
BLOCK 12: Vib with Top Load Face 3	313.1Lbs.	P	P	NA	NA	NA	
BLOCK 12: Vib with Top Load Face 4	128.6Lbs.	P	P	NA	NA	NA	
BLOCK 12: Vib with Top Load Face 6	50.1Lbs.	P	P	NA	NA	NA	
BLOCK 12: Vib Face 3 (Pick-Up Truck)	0 Lbs.	P	P	NA	NA	NA	
BLOCK 20: Inclined or Horizontal Impact	(inches/sec)	NA	NA	NA	NA	NA	Required for packages =>100 lbs (45 kg)
BLOCK 15: Drop 10-15	18 INCHES	P	P	NA	NA	NA	
BLOCK 15: Drop 16	36INCHES	P	P	NA	NA	NA	Face 6
BLOCK 15: Drop 17	18 INCHES	P	P	NA	NA	NA	Face 3
BLOCK 24: Concentrated Edge Impact	Pass	P	P	NA	NA	NA

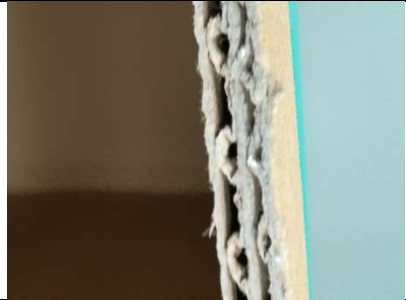
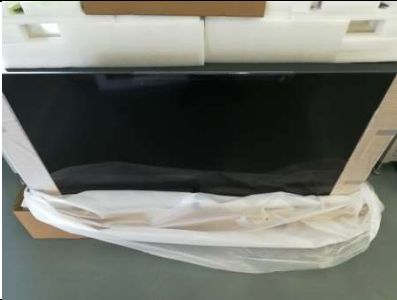
Overview	The submitted samples Passed the test requirement per ISTA 6-Amazon.com-SIOC:2018-Type G with on visible damage.
Product Condition	No visible damage was found on the product.
Packaging Condition	No visible damage was found on the package and material.

TV turned on	TV turned on	TV turned on
